Evaluation of Subsea Global Solutions In-Water Cleaning and Capture Technology for Ships

April 3, 2019

This test report presents the results of evaluating the efficacy of removal and capture of fouling organisms and debris by Subsea Global Solutions (SGS) Whale Shark in-water cleaning and capture (IWCC) technology at two testing sites: NS *Savannah* in the Port of Baltimore (4601 Newgate Ave., Baltimore, MD) and MV *Cape Orlando* in the Port of Alameda (Pier One, Alameda Point, 1499 Ferry Point Road, Alameda, CA). The SGS Whale Shark IWCC system was tested under the direction of the Alliance for Coastal Technologies (ACT) and Maritime Environmental Resource Center (MERC), in collaboration with the:

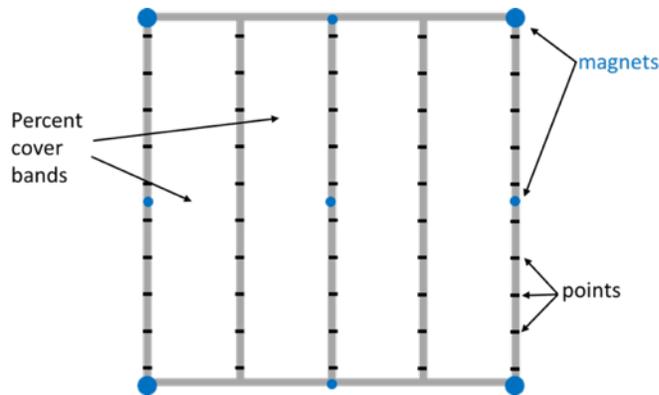
Figure 1. Quadrats were used to determine biofouling cover in two ways. Firstly, using a point count method of 50 points on the 1m² area, and secondly using percent cover visual estimates within the four bands of space within the quadrat.

The same low-visibility survey methods were used in both Baltimore and Alameda. A 1m² magnetic quadrat with a grid of 50 points was placed on hull surfaces, and the point count method was used to record biofouling or hull surface under all 50 points (Figure 1). An additional record of percent cover in four quadrants (bands) of the quadrat was taken to ensure the entire 1m² area was accounted for (Figure 1).

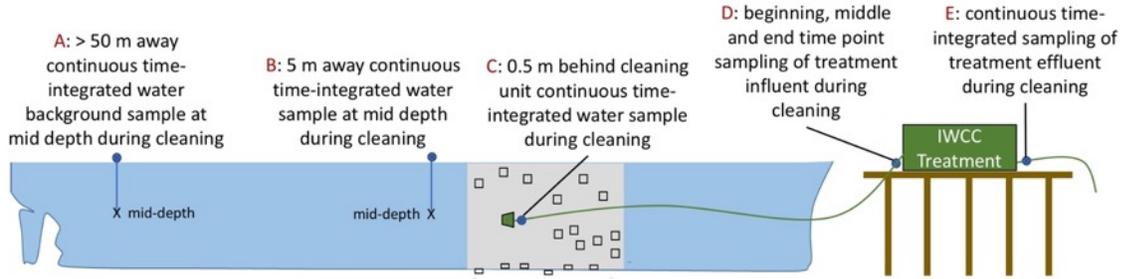
Figure 2. Diagrammatic example (not to scale) of sample points over the delimited cleaning area (grey; see Figure 1 for details regarding the replicate plots within each stratum) and adjacent to the ship and the cleaning area (A-E). Stations F1, F2 and F3 are not included in the diagram. This sampling scheme represented a total of 16 samples for each test, with each analysis conducted in triplicate to quantify analytical variance.

- F. *Characterizing background environmental variance*. Three additional set locations (not shown in Figure 2), located 5 m (F1), 50 m (F2) and 100 m (F3) away from the vessel hull, were sampled using a 4.2 L Van Dorn-style horizontal water sampler at 3 m depth (approximately mid depth of hull cleaning area), at three different time points: 1 day before the test (T0), 1 hour before the test (T1), and a mid-point (T2) during the test. A total of 9 liters was collected at each site at each time point. Each 9 L sample was uniformly mixed prior to collecting subsamples for triplicate analyses of TSS, copper, and zinc. A quality control replicate was collected at F2-T0 for triplicate analysis of TSS, copper, and zinc.

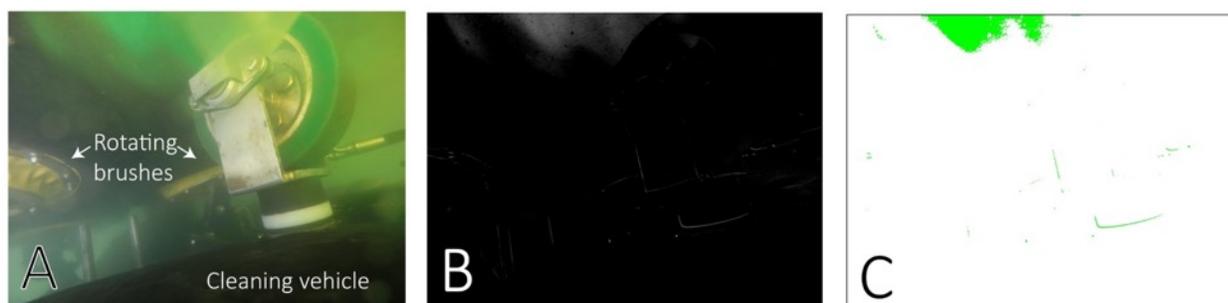
Figure 3. Example processing of an image. Shown here is the image at the start of the sequence (0 s). Images collected during the release of fluorescein dye (A) were processed to select regions with colors corresponding to the dye (B). These regions were used to create a mask (C), such that the number and intensity values of pixels within the masked region could be used to estimate the relative volume and concentration of the dye.

Processing Toolbox (R2017b, The Mathworks, Natick, MA). Figure 3 shows a schematic of the processing routine. The color image shows the cleaning vehicle, one of its wheels, and two rotating brushes (Figure 3A). The color images contained several regions shaded with green (including the wheel, but also the seawater, which was tinted green in the ambient and camera light). This green background was subtracted from the subsequent images so that the fluorescein, which had a unique greenish hue, could be differentiated from the background color. The images were segmented to only include the colors corresponding to the fluorescein, resulting in a pixel intensity map (Figure 3B). An image mask was created (Figure 3C), so that all pixels with value >20 of an 8-bit scale (maximum intensity=256) were selected. The number and intensity values of all pixels within the masked region were used to estimate the relative volume and concentration of the fluorescein in the image sequence.

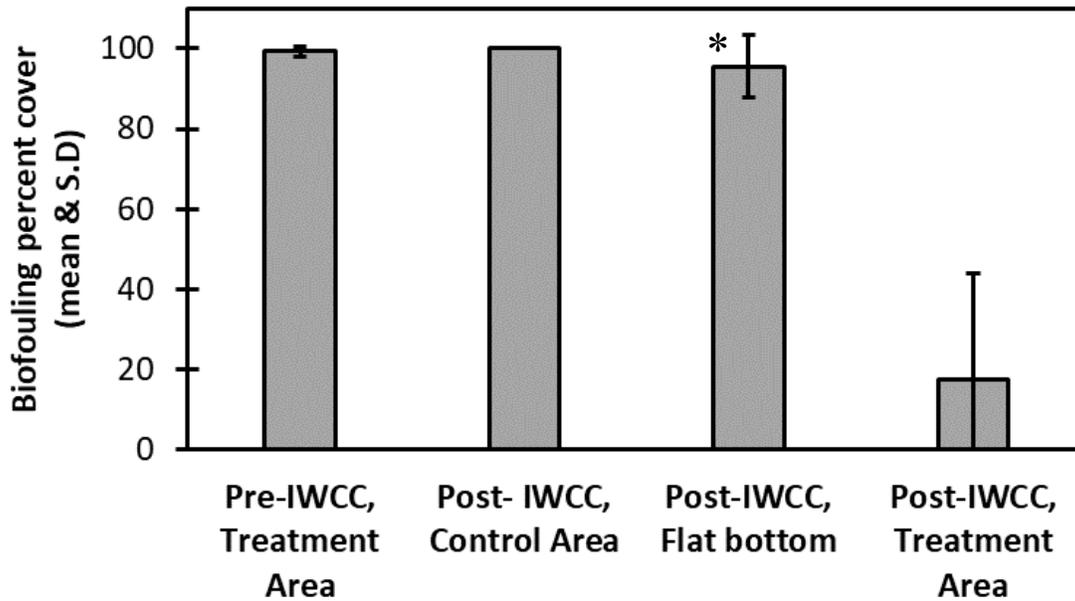
Figure 4. Average biofouling percent cover across four sampling strata (\pm SD). Biofouling was reduced significantly as a result of in-water cleaning. Pre-IWCC treatment area ($n = 15$); post-IWCC control area ($n = 20$); post-IWCC flat bottom ($n = 5$); post- IWCC control area ($n = 15$). *Although it was initially agreed that the vessel flat bottom would be included in the test area, access for IWCC system was limited and unsafe because of proximity to the bottom. Therefore, although fouling was quantified, the flat bottom was not cleaned.

5), but these were recorded as bare space. Results from diver estimates of percent cover were almost identical to point count data, indicating no additional patchiness or sources of small-scale variation in biofouling cover occurred. Percent cover estimates also differed among sample areas, with three groups approximating 100% and post-cleaning area average cover of 15% ($\pm 24.9\%$).

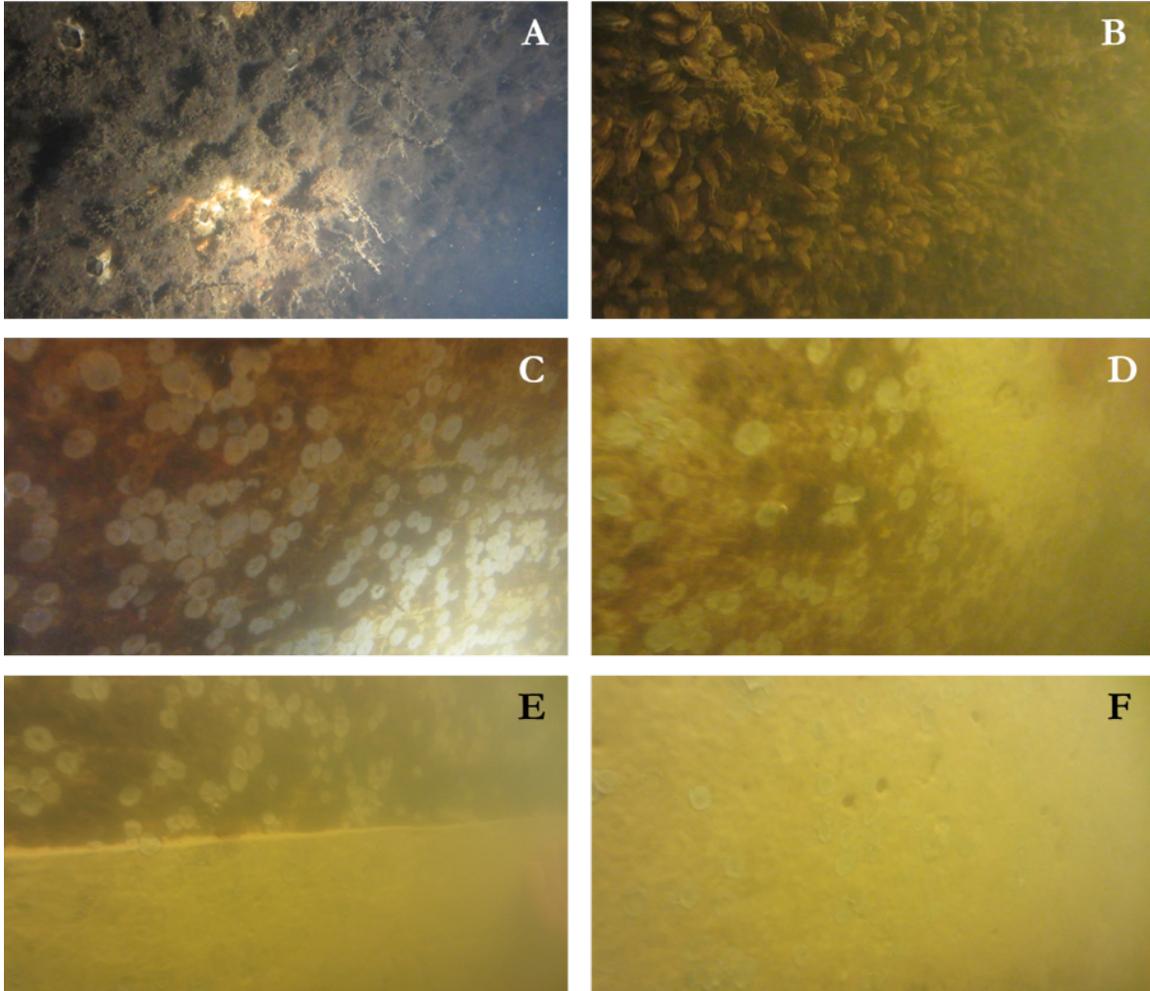
Figure 5. Still images captured from video of the hull of the NS *Savannah*. 100% cover of biofouling was present in untreated areas of the hull, including *Victorella pavida* and barnacles (A) and mussel dominated areas (B). The effect of cleaning was substantial, typically removing most of the three-dimensional structure of biofouling, with barnacle scars (bare space) visible, but also thin patches of *Victorella* in areas (C, D, E). Other hull surfaces within the treated area were completely cleaned of biofouling (F).

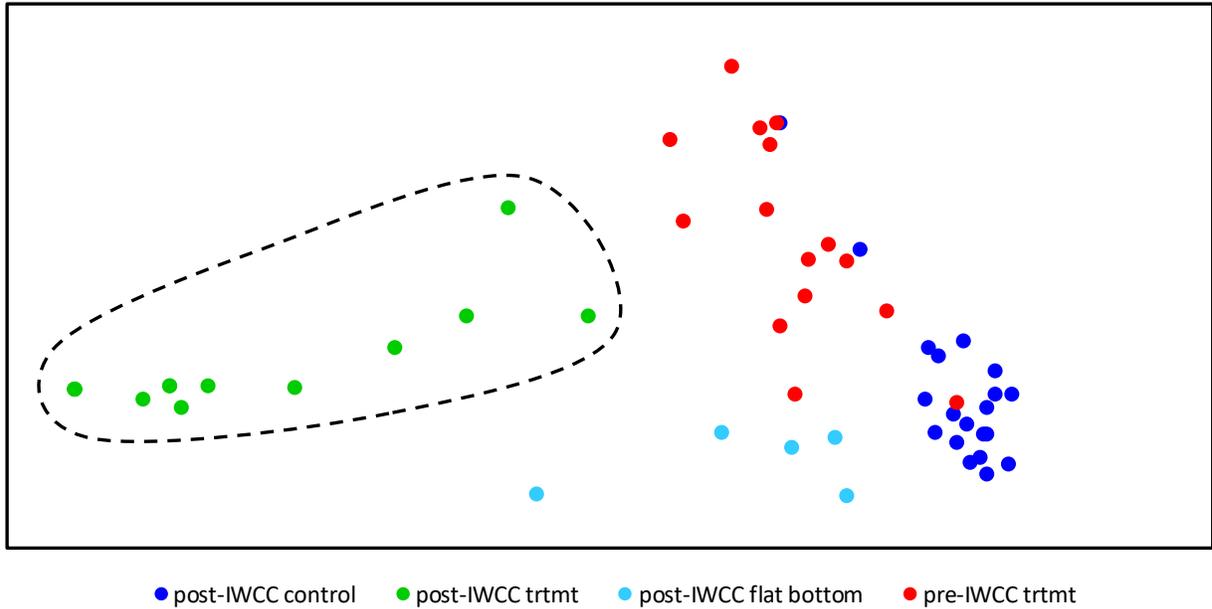
Figure 6. Multivariate analysis of percent cover by dominant biofouling groups from diver surveys of the NS *Savannah*. The treated area (within the dashed line) differed from pre-treatment and control area samples because of significantly reduced biofouling cover.

Multivariate analysis of hull biofouling supported the percent cover results by showing distinct differences in post-cleaning samples compared to pre-cleaning and control samples (Figure 6; PERMANOVA, $df = 3$, pseudo- $F = 50.88$, $p = 0.001$). Variation in biofouling composition occurred among sample areas mainly because (a) mussels were more prevalent in control areas than at the bow where cleaning occurred and (b) anemones were more prevalent on the flat bottom control area. The largest difference in composition among areas occurred because cleaning reduced cover of all taxa in the treated area and exposed bare space. The cleaned area had an average similarity of 12% with pre-cleaned and control areas, whereas the pre-treatment and control sample groups averaged 50% similarity to each other.

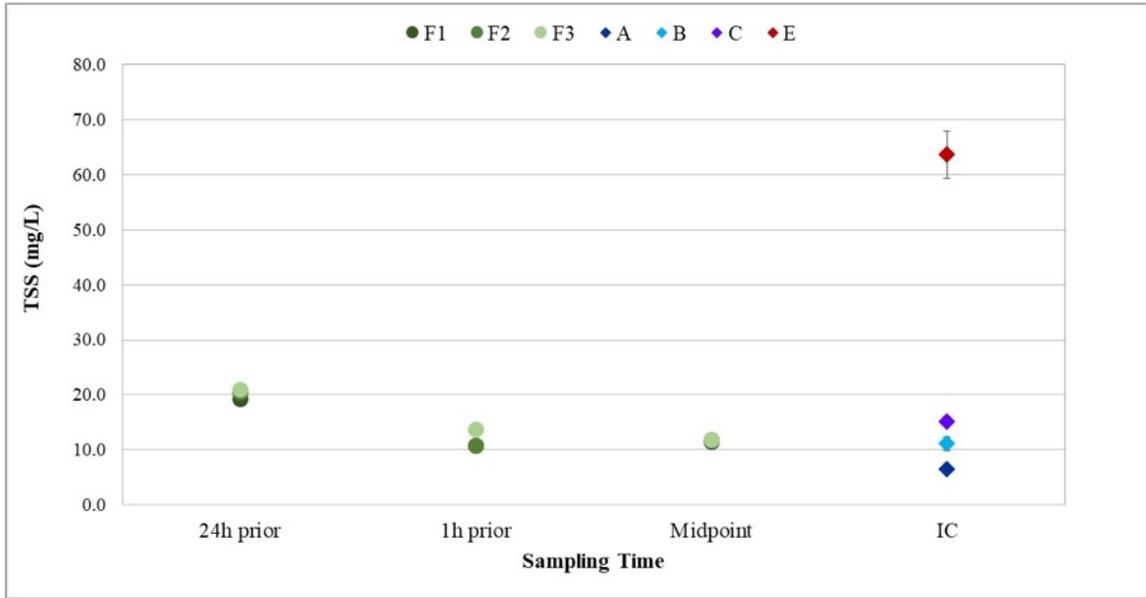
Figure 7. Time series of total suspended solids data for F1, F2, and F3 stations in Baltimore. Stations A, B, C, and E show the data for TSS samples collected continuously throughout the test period (IC). The 95% confidence (CI) intervals are shown in the error bars. The 95% CI for some stations were too low to display on the graph. Station D is not shown.

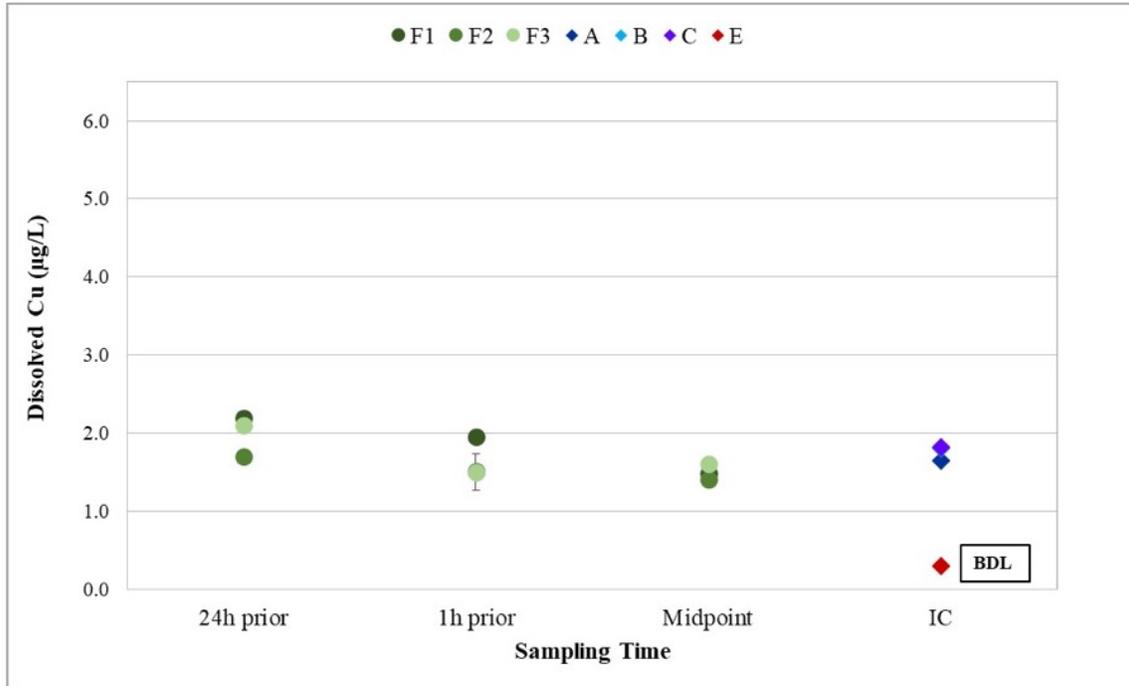
Figure 8. Time series of dissolved copper data for F1, F2, and F3 stations in Baltimore. Stations A, B, C, and E show the data for dissolved Cu samples collected continuously throughout the test period. The 95% confidence (CI) intervals are shown in the error bars. The 95% CI for some stations were too low to display on the graph. Station D is not shown (see Table 7 above). Station E is BDL. The detection limits are shown in Table 9.

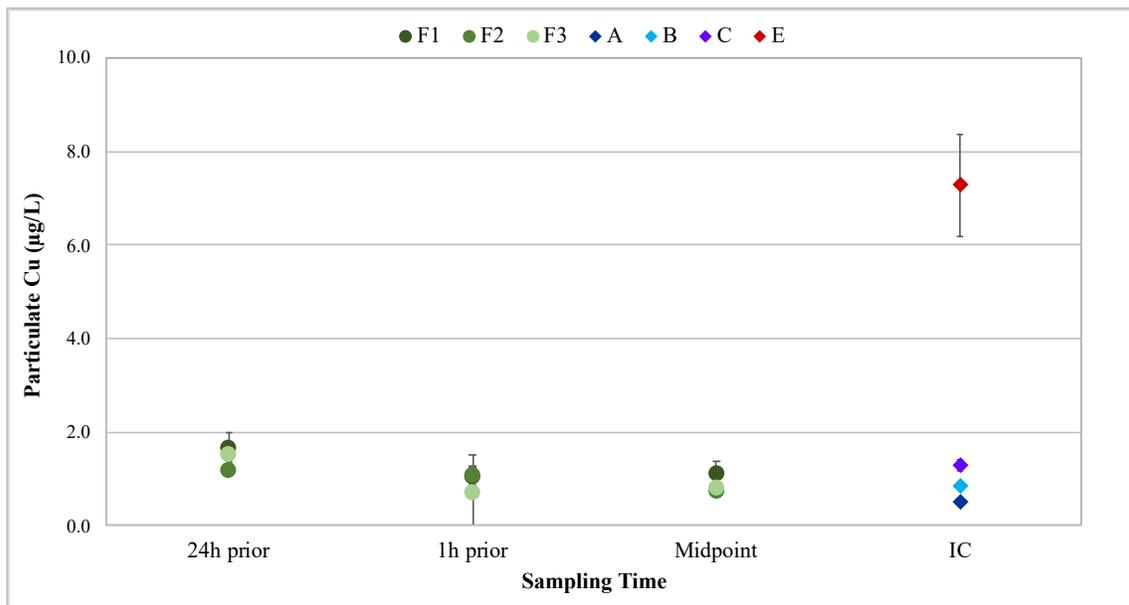
Figure 9. Time series of particulate copper data for F1, F2, and F3 stations in Baltimore. Stations A, B, C, and E show the data for particulate Cu samples collected continuously throughout the test period. The 95% confidence intervals are shown in the error bars. The 95% CI for some stations were too low to display on the graph. Station D is not shown (see Table 7 above).

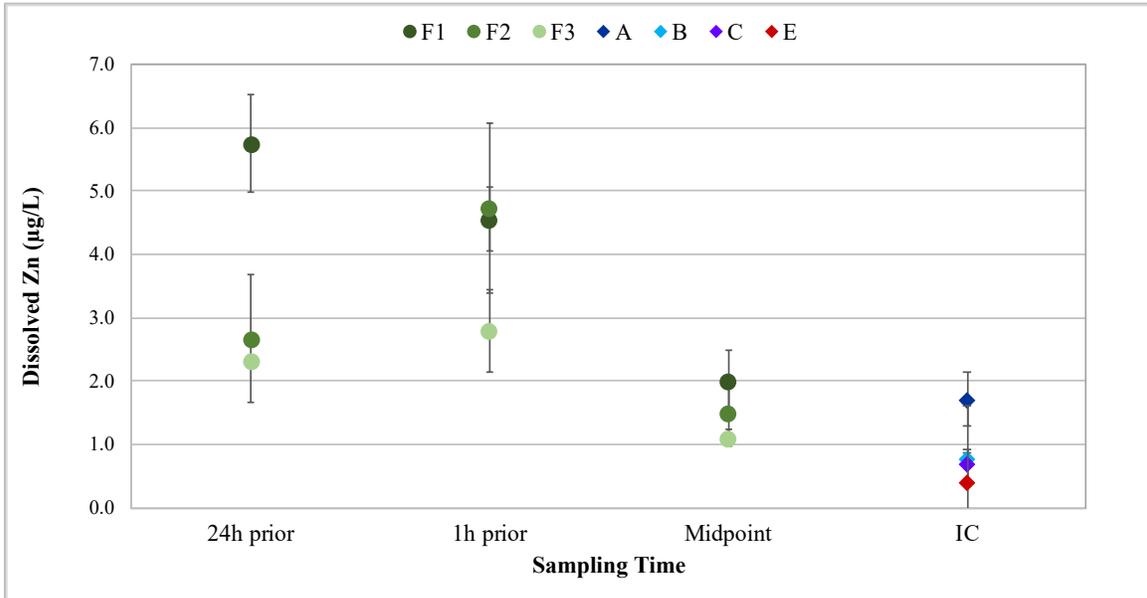
Figure 10. Time series of dissolved zinc data for F1, F2, and F3 stations in Baltimore. Stations A, B, C, and E show the data for dissolved Zn samples collected continuously throughout the test period. The 95% confidence intervals are shown in the error bars. Station D is not shown (see Table 8 above). Stations B, C, and E were BDL. The detection limits are shown in Table 9.

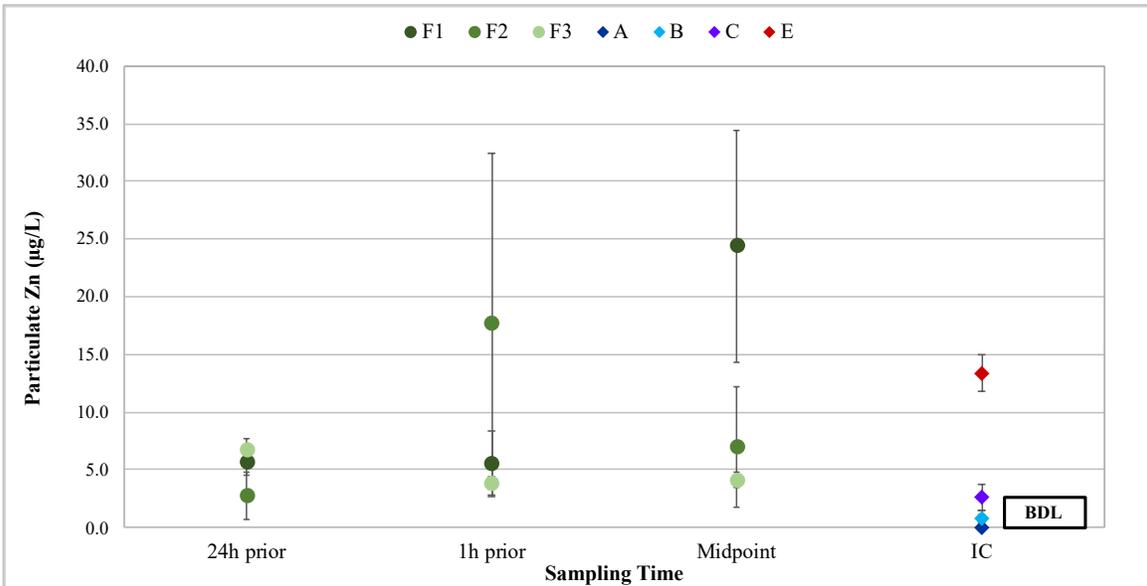
Figure 11. Time series of particulate zinc data for F1, F2, and F3 stations in Baltimore. Stations A, B, C, and E show the data for particulate Zn samples collected continuously throughout the test period. The 95% confidence intervals are shown in the error bars. Station D is not shown (see Table 8 above). Stations A and B were BDL. The detection limits are shown in Table 9.

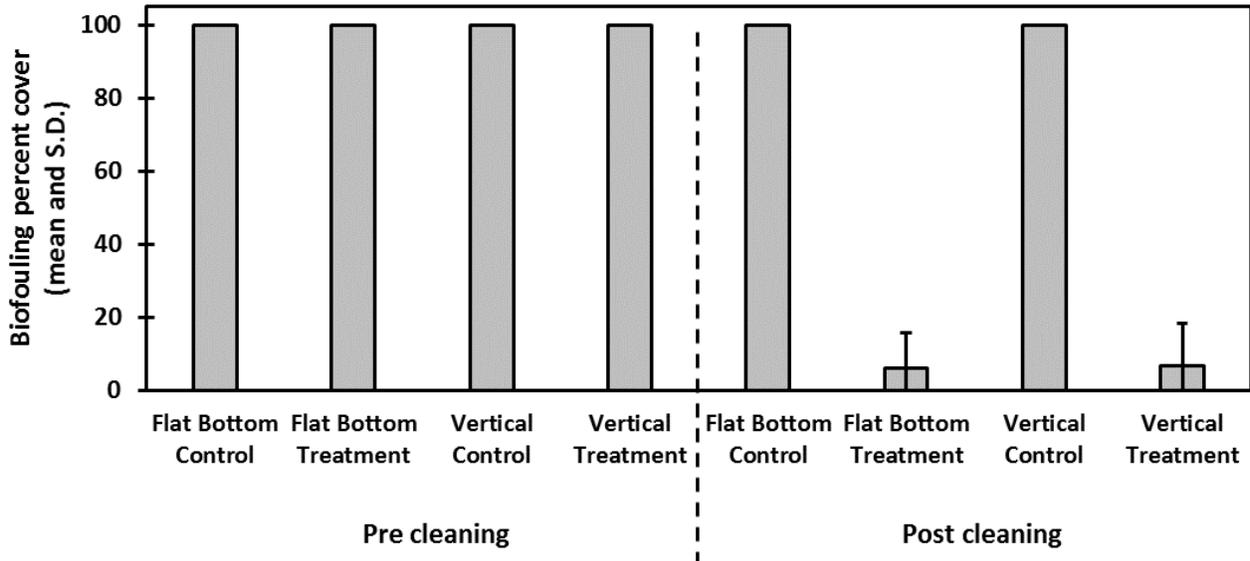
Figure 12. Average biofouling percent cover across eight sampling strata (\pm S.D.). Biofouling was reduced significantly because of in-water cleaning. $n = 10$ replicates for all sampled areas. Error bars for all strata at 100% average cover were zero (no variability).

In-water cleaning caused a strong and significant reduction in biofouling cover on the MV *Cape Orlando* (KW test, $df = 7$, $H = 77.59$, $p < 0.001$). The ship had 100 % cover of thick biofilm (FR20) uniformly across all hull surfaces, with occasional patches of macrofouling species, prior to vessel cleaning. Percent cover of these organisms did not change in control areas after the cleaning event, but was greatly reduced in treated areas (Figure 12). Biofouling was entirely absent from 14 of the 20 post-cleaning treated area samples.

In-water cleaning had the effect of applying brush marks and scratches to the coating that were quite visible in post-cleaning treatment areas (Figure 12, likely only the top layer of the multilayer hull coating system was impacted). Just 10 % of pre-cleaning samples (4 out of 40) had visible blemishes to the coating: two on the vertical side had scratched, flaking or pitted coating while two flat-bottom quadrats included dock block areas. Samples from post-cleaning control areas all had good coating condition. Blemishes in the coating were more prevalent in the treatment area after cleaning, whereby 65 % of sample quadrats included brush marks, scratches, or flaking. It is possible that flaking and coating failures were results of poor pre-application cleaning or poor application of coating while in dry dock, and not associated with IWCC.

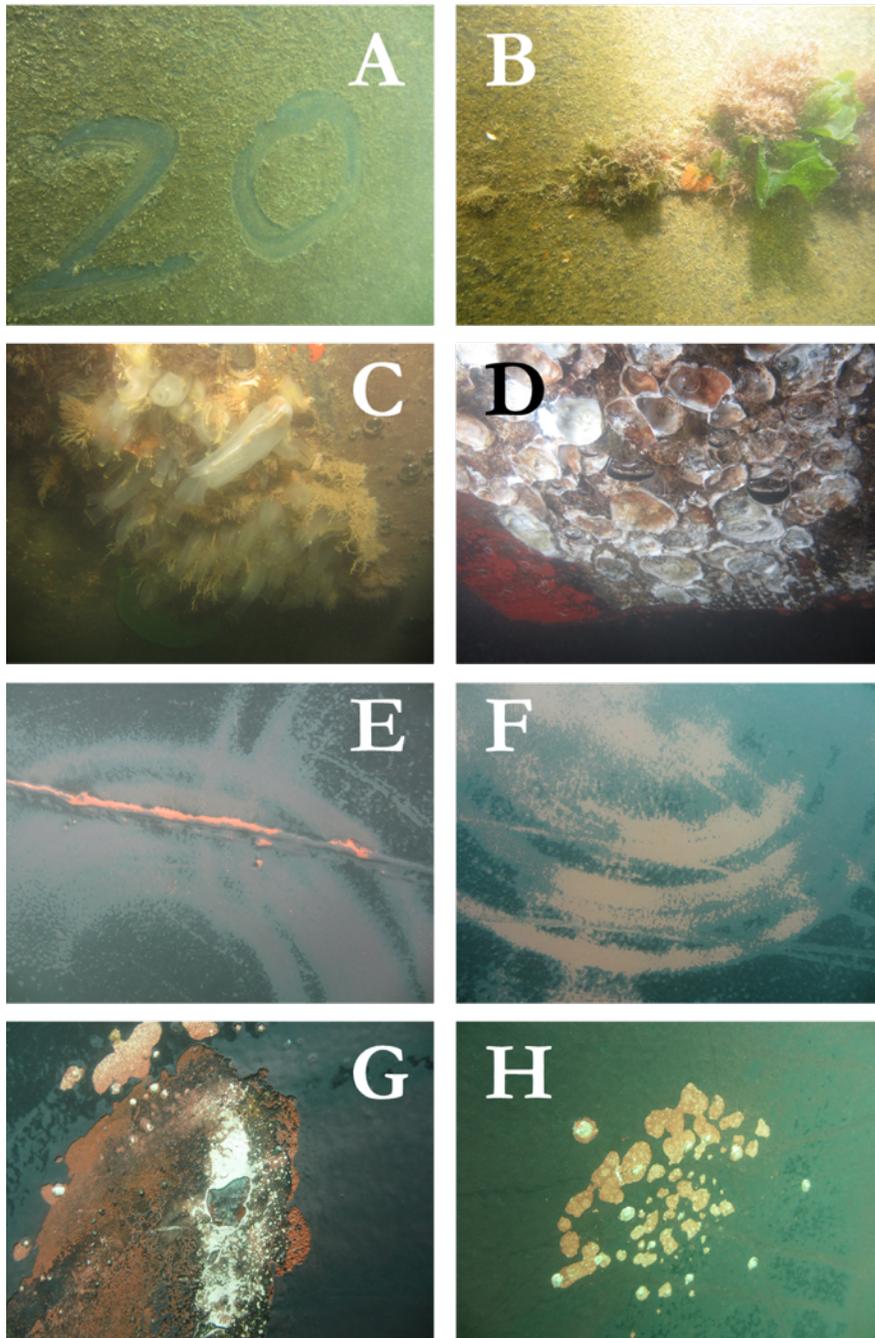
Figure 13. Still images of biofouling and cleaned surfaces on the MV *Cape Orlando*. A consistent cover of biofilm (A) was present throughout the hull surfaces prior to cleaning, with small patches of macrofouling (B) on vertical surfaces and larger patches in dock block areas on the flat-bottom (C). After cleaning, remnant biofouling in dock blocks was recorded (D), but biofilm and macrofouling cover were greatly reduced (often to zero in samples taken). Rotating brush marks and scratches were visible in the treatment area after cleaning (E & F), while some patches of flaking and coating removal or pitting was also observed (G & H).

During pre-cleaning sampling, 97 % of all sample points comprised biofilm cover (Figure 13). The remaining 3 % consisted of macrofouling organisms, which were primarily algae and *Bugula* (erect bryozoan) on vertical surfaces and bivalves, bryozoans and ascidians within dock block areas on flat-bottom surfaces (Figure 13). Residual biofouling recorded post-cleaning in flat-bottom treatment areas consisted of oyster shells, mussel byssus, and bryozoans and showed that dock block areas presented a challenge to cleaning. Remnant biota on cleaned vertical sides consisted of small patches of biofilm or algae, which appeared to have been missed by passing brushes rather than simply being retained on the hull despite being brushed.

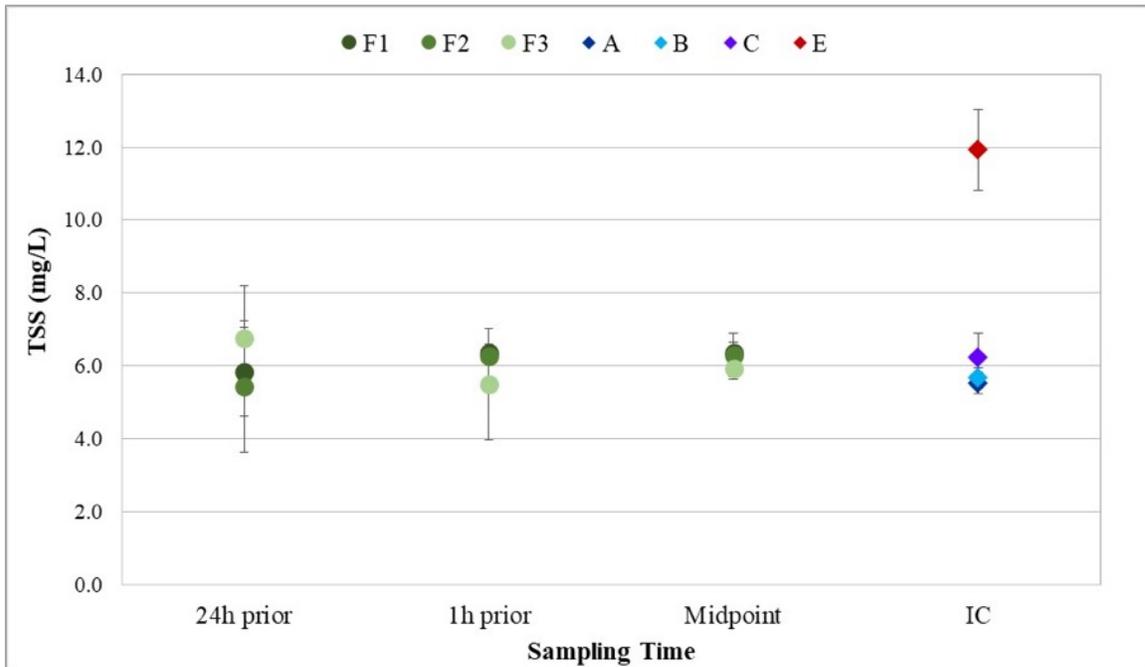
Figure 14. Time series of total suspended solids data for F1, F2, and F3 stations in Alameda. Stations A, B, C, and E show the data for TSS samples collected continuously throughout the test period. The 95% confidence intervals are shown in the error bars. Station D is not shown (see Table 14 above).

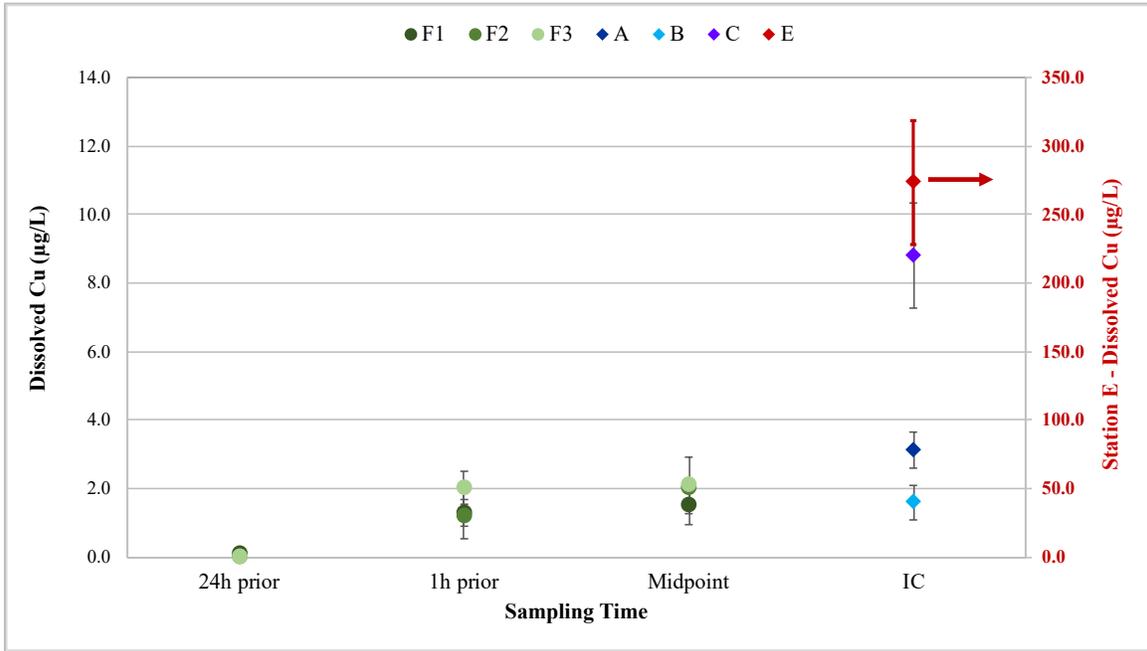
Figure 15. Time series of dissolved copper data for F1, F2, and F3 stations in Alameda. Stations A, B, C, and E show the data for dissolved Cu samples collected continuously throughout the test period. The 95% confidence intervals are shown in the error bars. Station D is not shown (see Table 16 above). All of the data except station E were below reporting limits. The reporting limits are shown in Table 18.

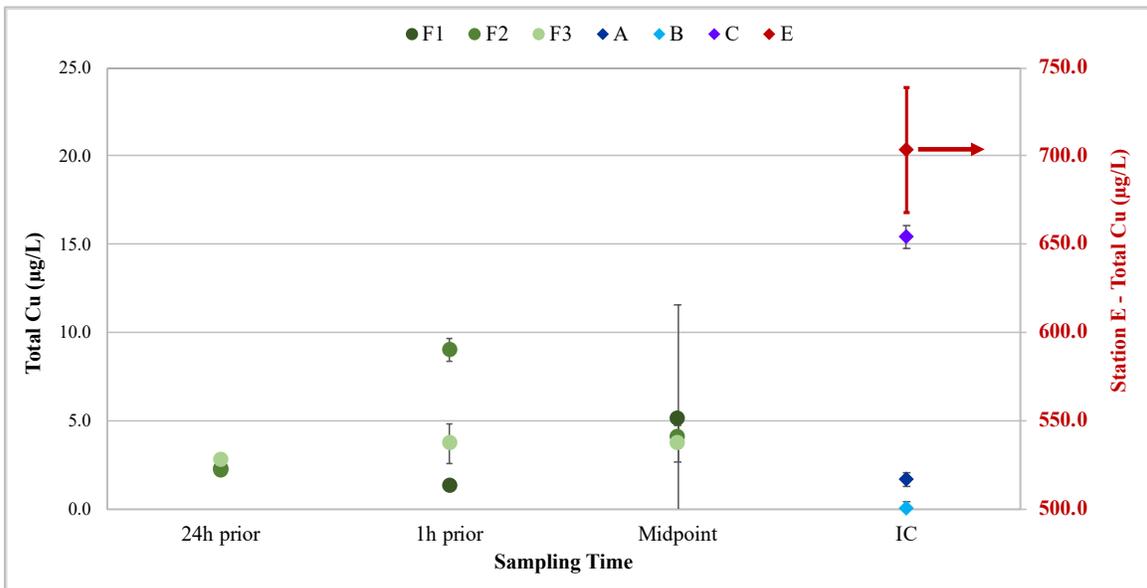
Figure 16. Time series of total copper data for F1, F2, and F3 stations in Alameda. Stations A, B, C, and E show the data for total Cu samples collected continuously throughout the test period. The 95% confidence intervals are shown in the error bars. Station D is not shown (see Table 16 above). All data except F1-T0, F2-T0, F3-T0, and E were below reporting limits. The reporting limits are shown in Table 18.

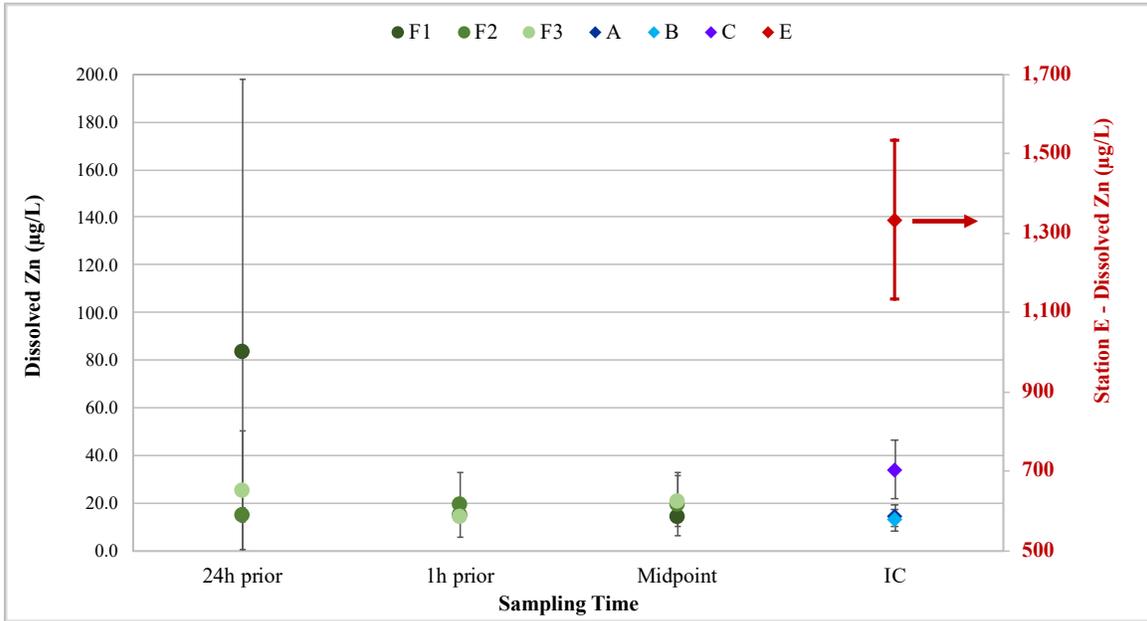
Figure 17. Time series of dissolved zinc data for F1, F2, and F3 stations in Alameda. Stations A, B, C, and E show the data for dissolved Zn samples collected continuously throughout the test period. The 95% confidence intervals are shown in the error bars. Station D is not shown (see Table 17 above). All of the data except station E were below reporting limits. The reporting limits are shown in Table 18.

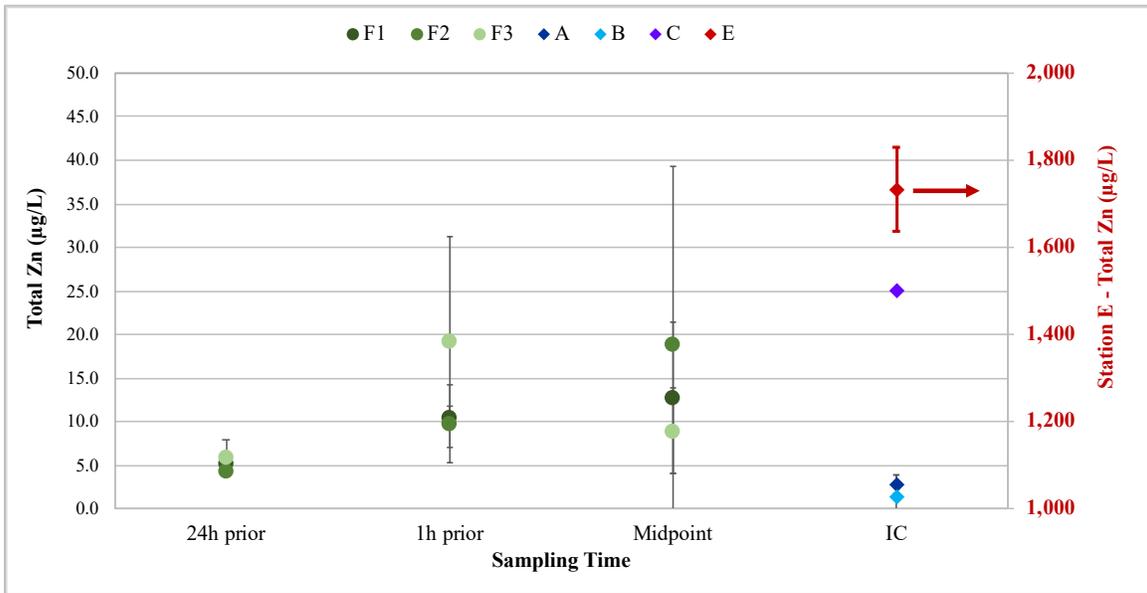
Figure 18. Time series of total Zn data for F1, F2, and F3 stations in Alameda. Stations A, B, C, and E show the data for total Zn samples collected continuously throughout the test period. The 95% confidence intervals are shown in the error bars. Station D is not shown (see Table 17 above). All of the data except station E were below reporting limits. The reporting limits are shown in Table 18.

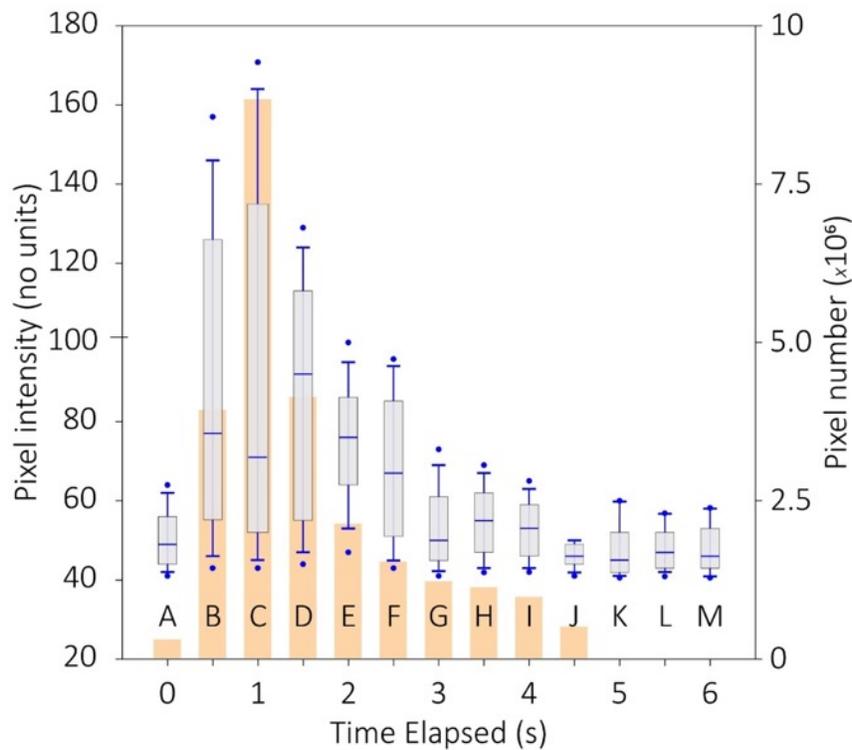
Figure 19. Pixel intensity (relative units on an 8-bit, or 256 value scale) and number of pixels (of 12×10^6 total) of a sequence of images with fluorescein dye. Pixel intensity is shown as box plots, with 5th and 95th percentiles marked by blue symbols, 10th and 90th percentiles marked by error bars, 25th and 75th percentiles marked by box limits, and the 50th percentile (the median pixel intensity) marked by a line within the box. Number of pixels are shown in orange bars, underlying the box plots. Image identifiers A-M correspond to example images in Figure 20.

Dye volume and concentration was estimated by analyzing an image sequence showing the course of dye release and uptake. Figure 19 shows the pixels intensity in a sequence of 13 images, which include the opening of the dye pack and release of the dye, which occurred early (within the first 1.5 s) of the sequence (corresponding to panels A-C of Figure 20). Mean pixel intensity returned to the baseline level within 2.5 s of the release (at 4.5 s). At most, in Image C, at 1.5 seconds, 8.9×10^6 pixels (75% of the total) contained fluorescein. The last image (Image M at 6 s) had <8000 pixels with fluorescein (Figure 20).

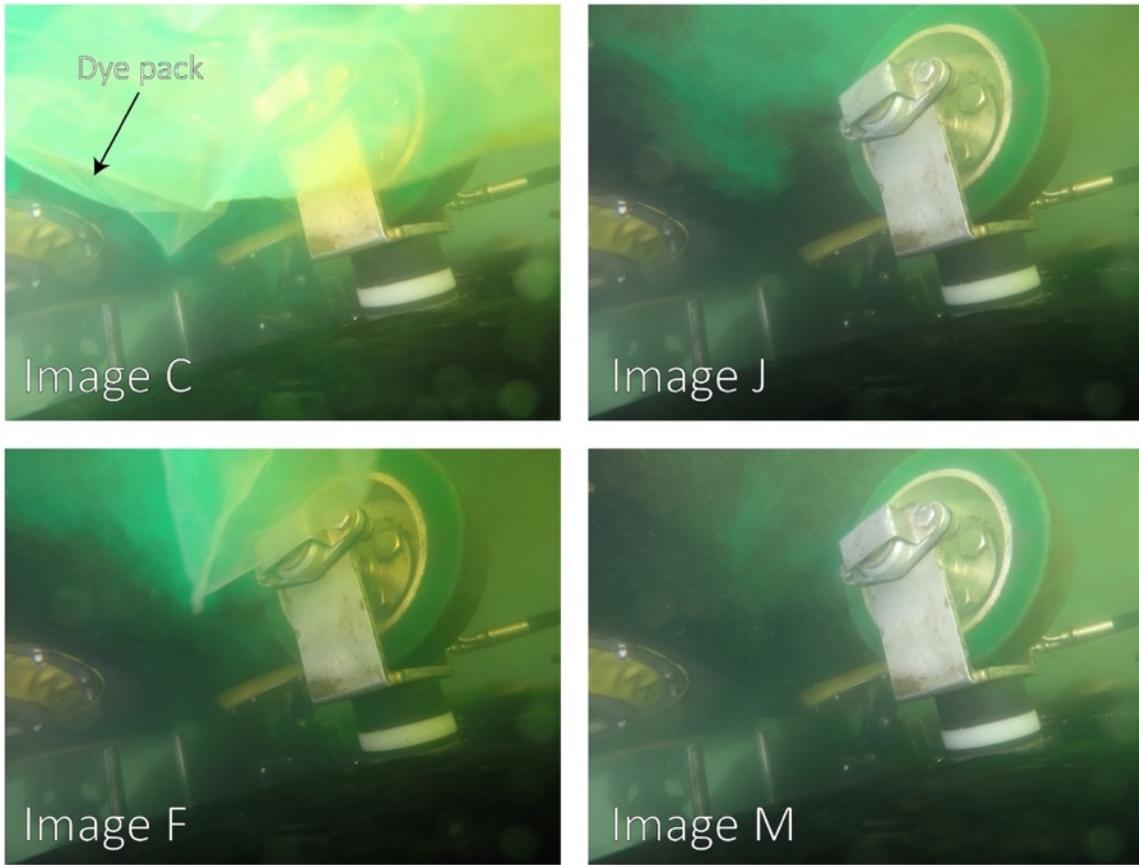
Figure 20. Example images from the sequence of dye pack release. The dye pack is visible in Image C and F. Image labels correspond to the labels in Figure 19, where Image C, F, J, and M were collected at 1, 2.5, 4.5, and 6 s into the sequence.

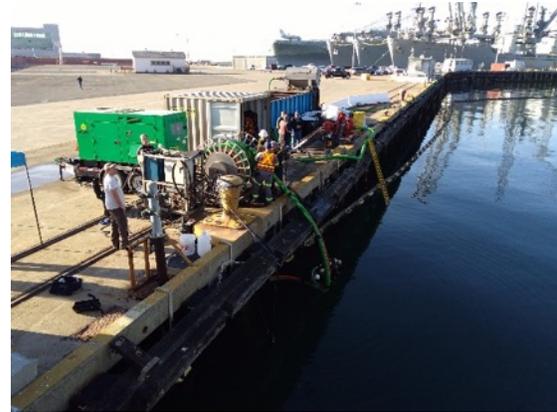
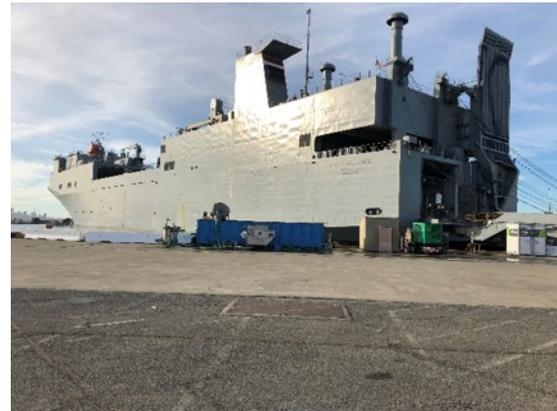
The Remora cleaning system allows for full height adjustment of the hydraulically driven triple brush system. This allows total control of the brush tension on the hull and allows the diver to hover the brushes off the hull when the vehicle is stopped or riding over clean areas. The hover mode where the brushes are just above the surface of the coating creates a water vortex and removes the slime coating without contacting the surface of the paint. The Remora system is incorporating brush shrouds connected to a centralized on-board hydraulic pump that reclaims the spoils and water surrounding the cleaned hull area and vacuums the material to the surface for filtration and water treatment.

In-Water Cleaning Vehicle Features	
Dimensions	<i>L x W x H</i> 1500 mm x 1200 mm x 600 mm
Weight	150 Kg.
Cleaning Type	<i>Brush/Waterjet/other with specification</i> Brush
Cleaning Swath	<i>Width</i> 1000 mm
Cleaning Speed	48 meters per minute
Cleaning Deck	<i>Type/Characteristics</i>
Particle Reduction	<i>Type/Characteristics/Performance</i> Down to 1 micron if required
Effluent Pump	<i>Type, characteristics, power, flow rate, total dynamic head, etc.</i> Surface mounted suction pump
Particle Separation	<i>Any onboard separation or pre-treatment on vehicle?</i> <i>Type, characteristics.</i>
Vehicle Effluent Flow rate	<i>Size, length, volumetric flow rate</i>
MAX Vertical Head	<i>Characteristics and capability to transport effluent from vehicle to treatment system (i.e., max pier height)</i>
Drive	<i>Drive Control, Speed Range, etc.</i> Variable speed control system with 3 drive wheels with forward and reverse.

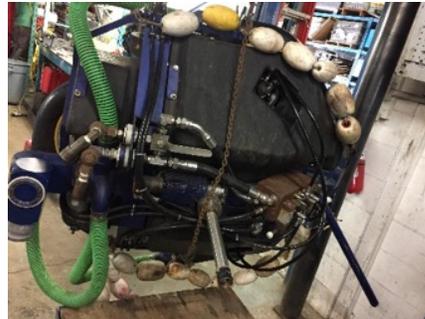
Mobile Support Unit Features	
Dimensions (L x W x H)	<i>L x W x H</i> 23 meters x 7.62 meters x 1.53 meters
Trailer Weight (EST)	70 tons while in operation
MSU Trailer	<i>Type (i.e. double drop)</i> NA
Generator	<i>Type/Power Output</i> Not Disclosed
Fuel	<i>Capacity/duration</i> Not Disclosed
Crane HPU	<i>Type, power, Characteristics</i> Not Disclosed
Diver Water Heater	<i>Capacity, length, Diameter</i> Not Disclosed
Control Van	<i>L x W x H</i> Included in overall dimensions
Dive Locker	<i>L x W x H and characteristics</i> Included in overall dimensions
Umbilical Hose Reel-Type	<i>Length, diameter</i> 100 meters- 10 cm
Articulating Crane	<i>Rating, capacity, reach</i> Not Disclosed
Power Block-Type	<i>Characteristics</i> Not Disclosed
Handheld Cleaner HPU/Reel	<i>Characteristics (power, ID, length)</i> Not Disclosed

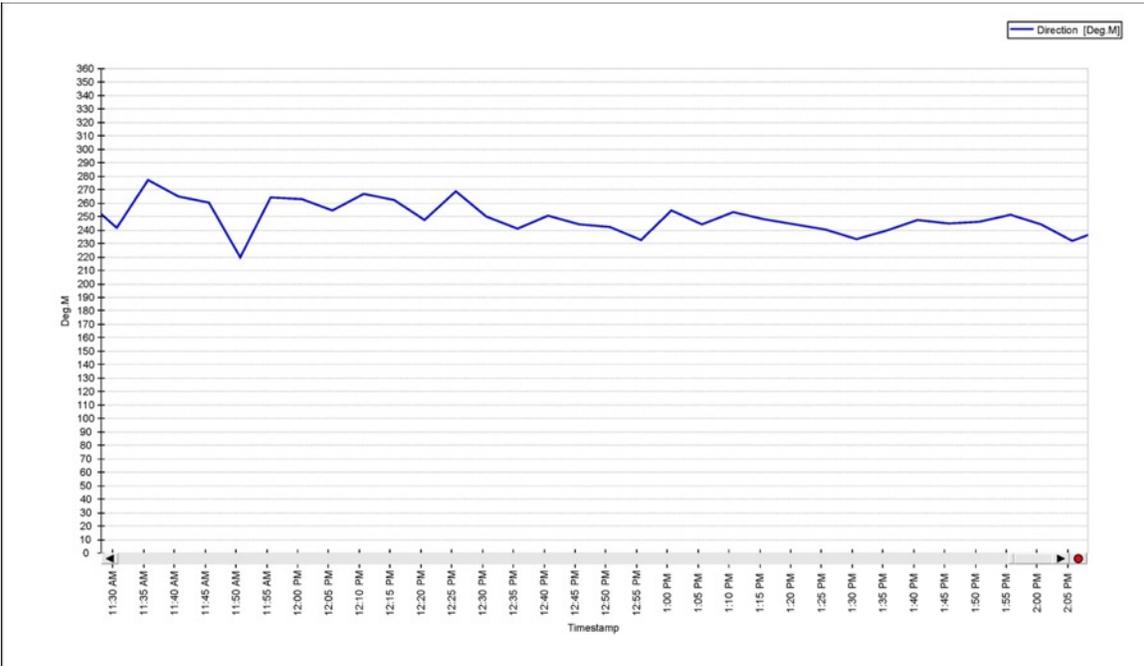
Figure D1. The direction of the current in Baltimore ranged from 230 to 250 degrees during T0 sampling on July 25th. The timestamp is in GMT. EST was 7:30am to 10:05am.

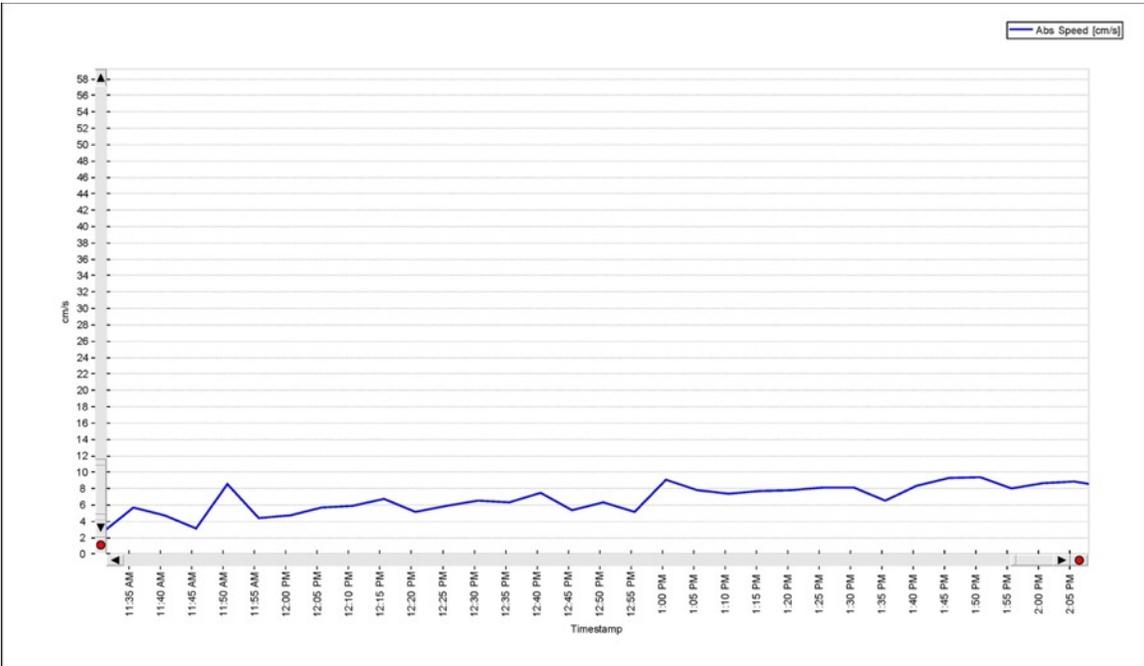
Figure D2. The current speed in Baltimore during T0 sampling ranged from 6 to 10 cm/s. The timestamp is in GMT. EST was 7:30am to 10:05am.

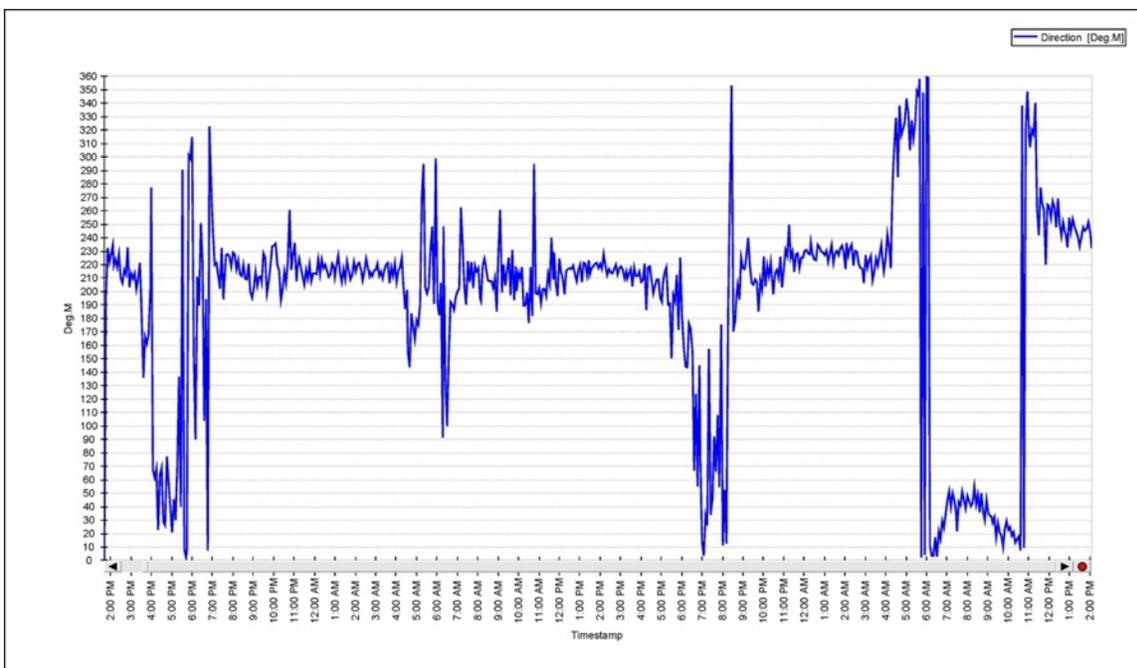
Figure D3. The direction of the current in Baltimore ranged from 0 to 360 degrees during the duration of deployment from July 24th to July 26th. The timestamp is in GMT. EST was 10:00am on July 24th to 10:00am on July 26th.

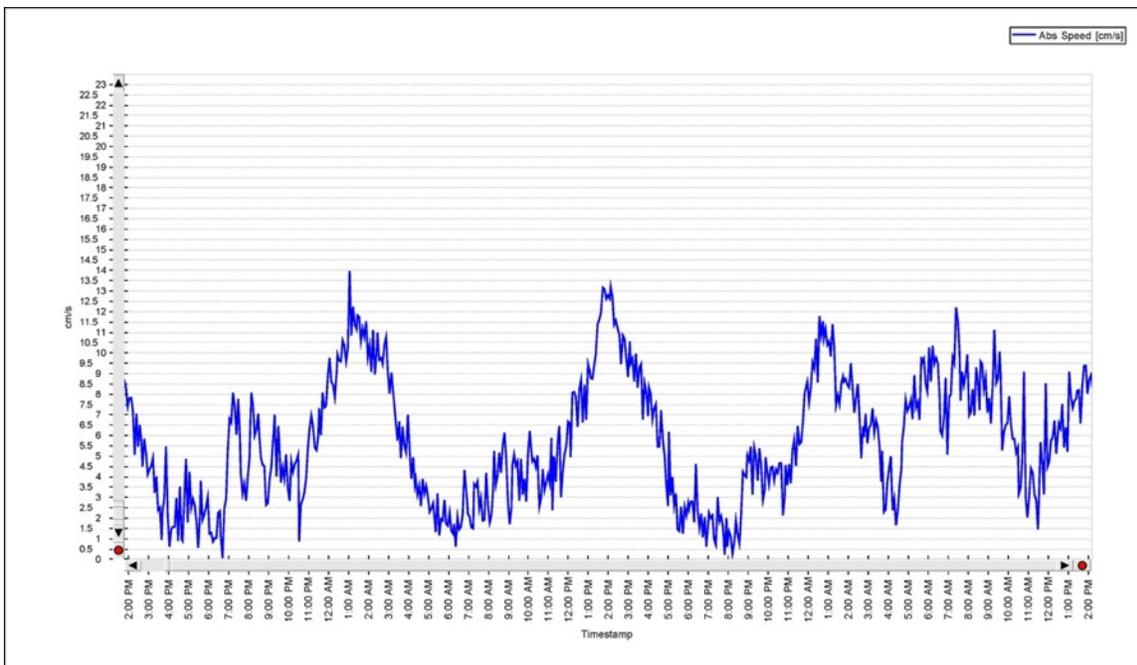
Figure D4. The current speed in Baltimore ranged from 0 to 14 cm/s during the duration of testing from July 24th to July 26th. The timestamp is in GMT. EST was 10:00am on July 24th to 10:00am on July 26th.
