Evaluation of Subsea Global Solutions In-Water Cleaning and Capture Technology for Ships

April 3, 2019

This test report presents the results of evaluating the efficacy of removal and capture of fouling organisms and debris by Subsea Global Solutions (SGS) Whale Shark in-water cleaning and capture (IWCC) technology at two testing sites: NS *Savannah* in the Port of Baltimore (4601 Newgate Ave., Baltimore, MD) and MV *Cape Orlando* in the Port of Alameda (Pier One, Alameda Point, 1499 Ferry Point Road, Alameda, CA). The SGS Whale Shark IWCC system was tested under the direction of the Alliance for Coastal Technologies (ACT) and Maritime Environmental Resource Center (MERC), in collaboration with the:

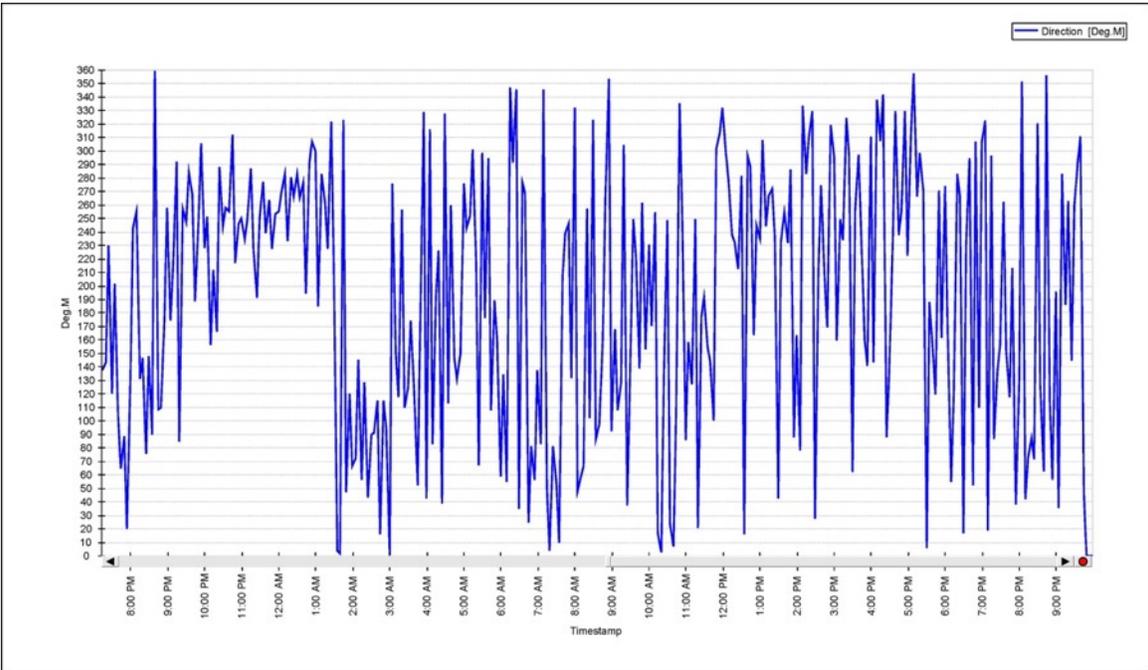
Figure D7. The current direction in Alameda ranged from 0 to 360 degrees during the main testing event on October 31st. The timestamp is in GMT. PST was 2:00pm on October 30th to 2:00pm on October 31st.

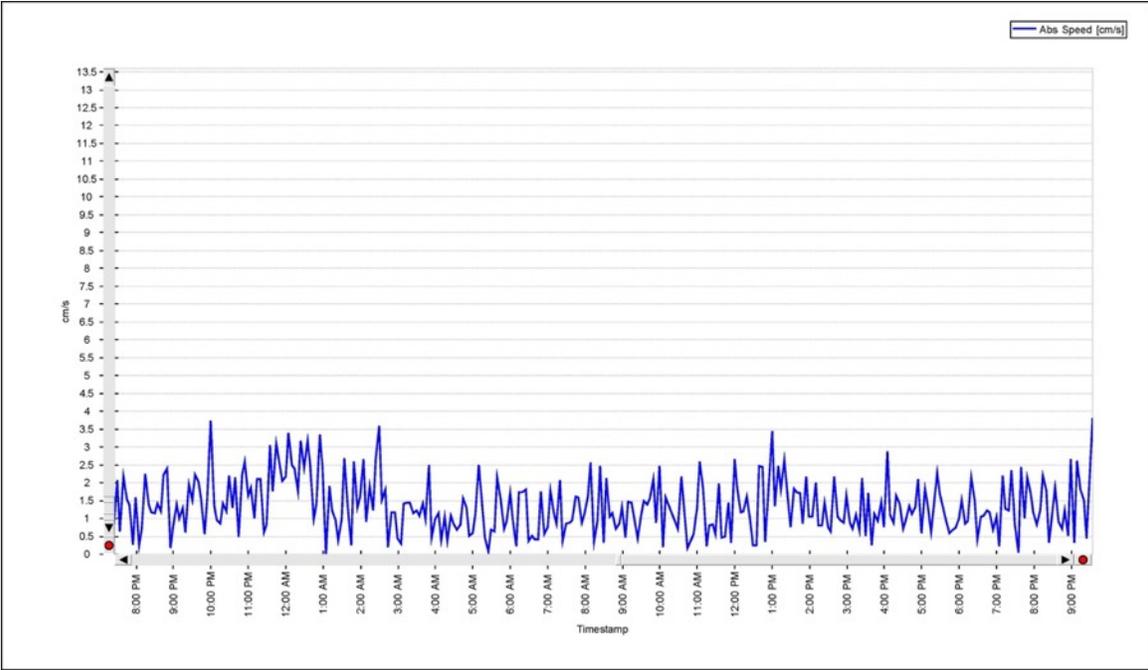
Figure D8. The current speed in Alameda ranged from 0 to 4 cm during the main testing event on October 31st. The timestamp is in GMT. PST was 2:00pm on October 30th to 2:00pm on October 31st.
